TRANSPORTATION SAFETY

REFLEXIONS

Issue 18 – September 2002

R A I L

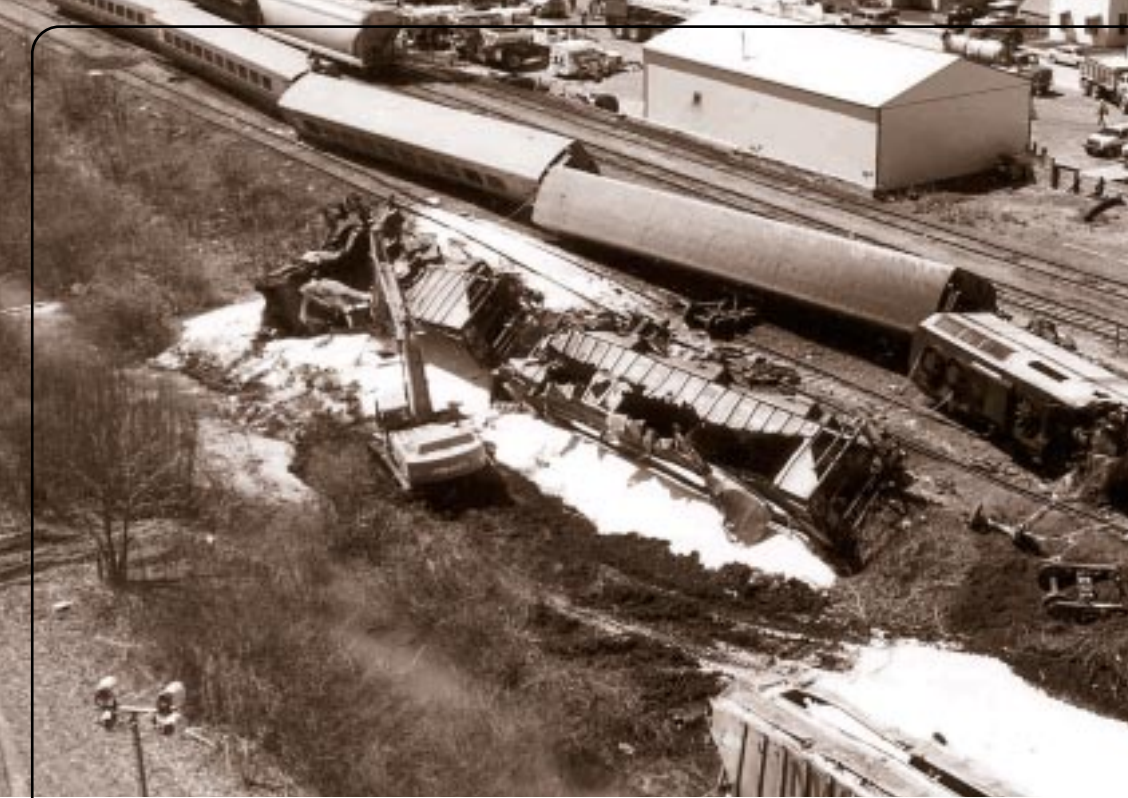
Overhead photograph of accident site looking northwest.

It was readily apparent that the derailment and collision resulted from a misaligned crossover switch. The crew and passengers on the Via train encountered an “unsafe condition”—a situation or condition that has the potential to initiate, exacerbate, or otherwise facilitate an undesirable event. The TSB’s investigation examined the circumstances that led to the existence of that unsafe condition, the reasons why it remained undetected and uncorrected, and methods of reducing the associated risks of accidents and their consequences.

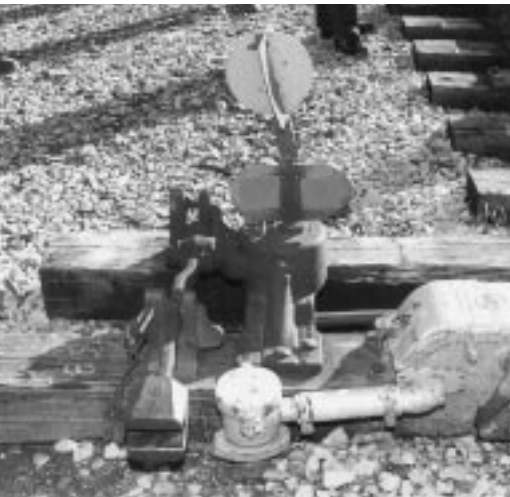
West crossover switch, Mile 46.72, lined and locked in 1'the reverse position.

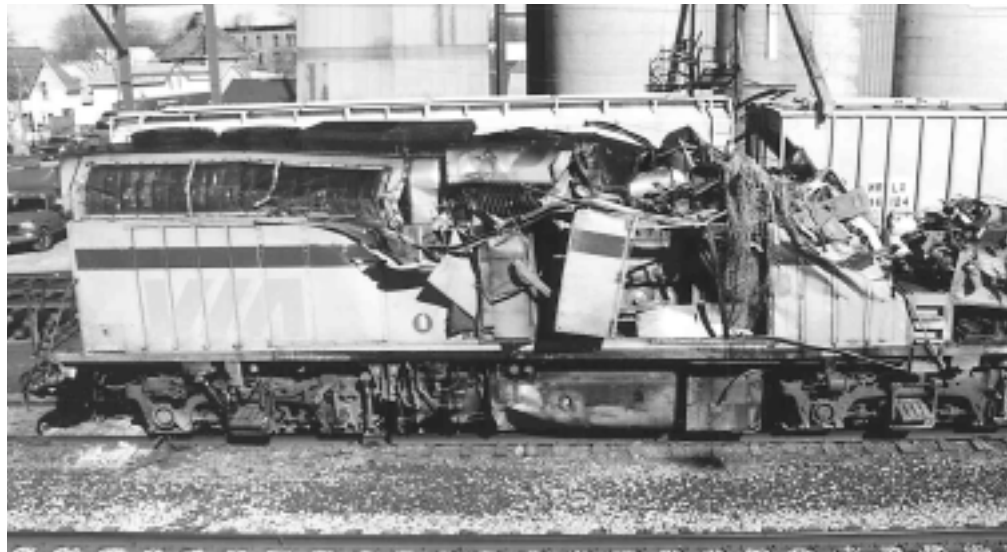
Right side shown after locomotive was righted. Damage is more extensive at the front right and along the right side of the locomotive.

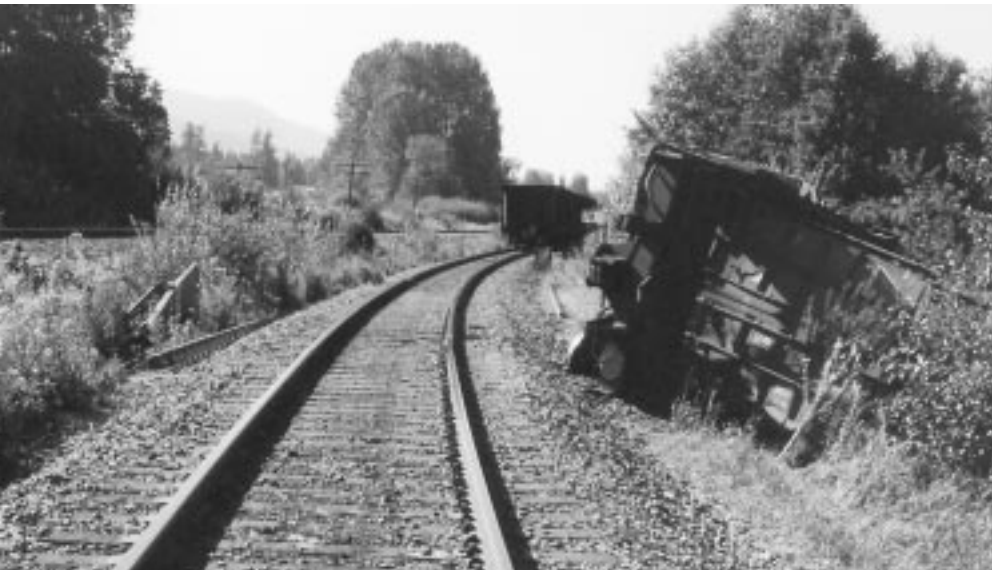
Rear-end car of train 839 at accident site.

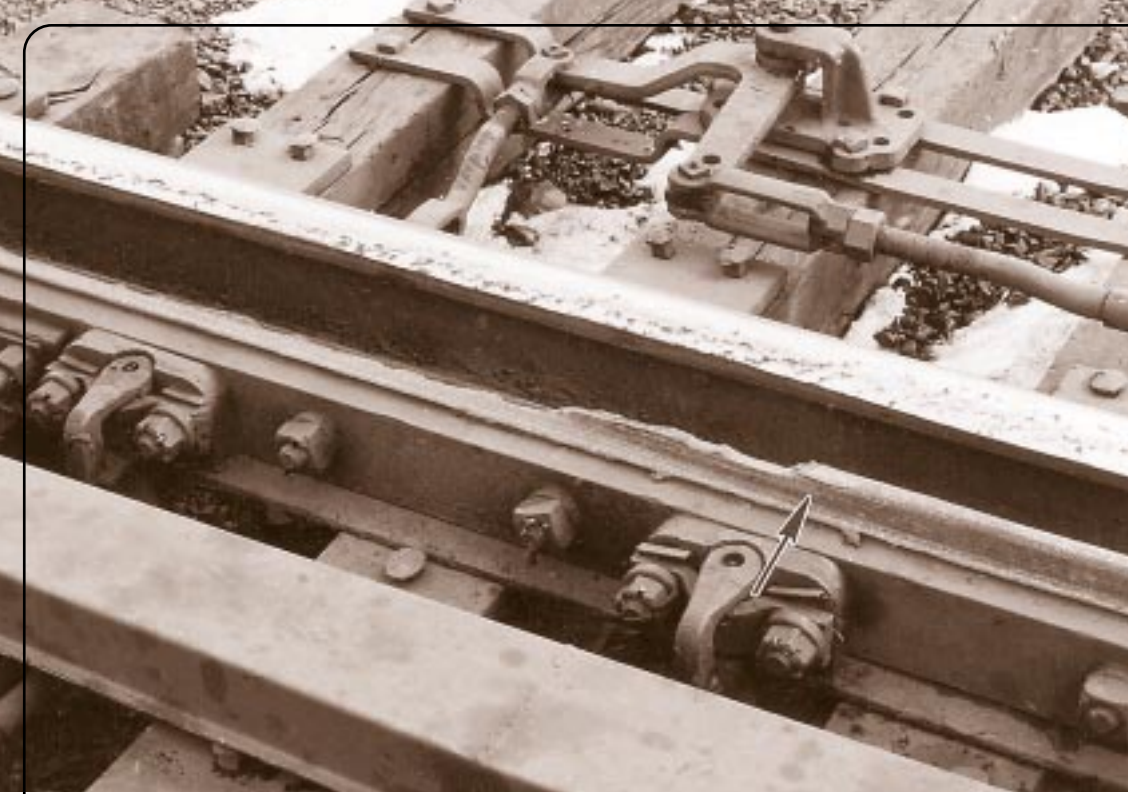
View of the missing section of the running surface of the switch point. The arrow points to a crack in the rail adjacent to missing head fragments.

The derailment occurred when a car wheel climbed over a defective switch point at the crossover. This switch point became defective due to the separation or chipping of large sections of the running surface along the point of the switch. The switch point was noted as being in poor condition 11 months before the derailment and, although subsequently inspected numerous times, no remedial action had been taken.

The switch point became defective when progressive chipping resulted in the separation of large sections of the running surface. This process eliminated the sharp taper of the upper portion of the point and resulted in a point thickness three times wider than the specified limit. At the time of the occurrence, the Standard Practice Circulars provided a 3/16-inch condemnable limit on the switch point end thickness; however, ratings such as "good", "fair", and "poor" were being used in the Detailed Monthly Turnout Inspection Report in this territory of the Kingston Subdivision.

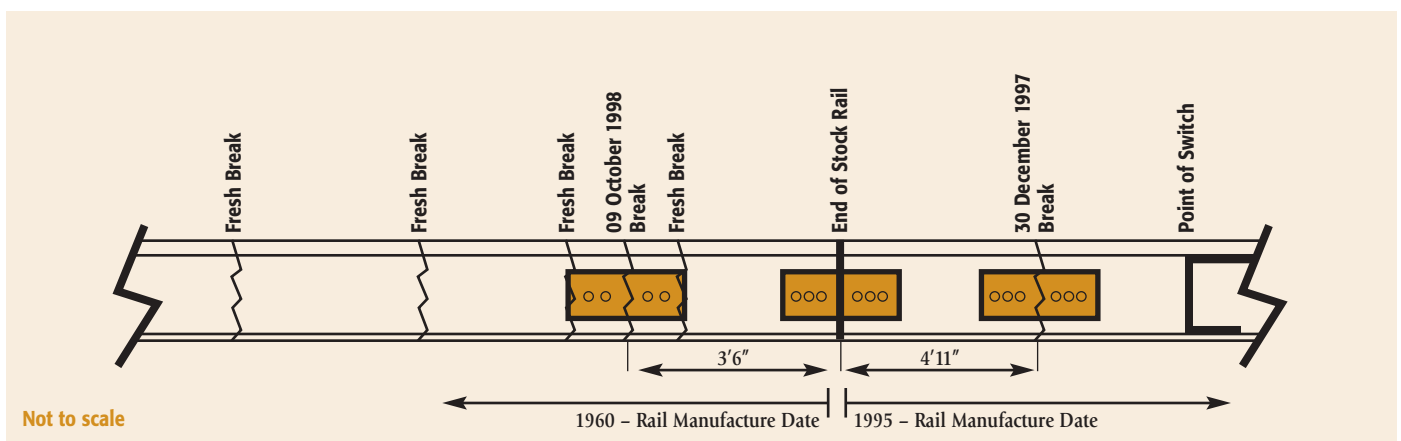
Layout of rail fractures.

The rail had broken at four locations. The fractures were on two adjacent rails, joined together with a four-bolt joint bar. One rail length was manufactured in 1960 and was relaid in 1989, having been moved from another location. The second one was manufactured and laid in 1995.

- The four recent rail fractures were mostly overstress in nature. A subsurface fatigue crack extending across approximately five per cent of the cross-section was observed on two fractures.
- Subsurface fatigue cracks were associated with shelling damage. Subsurface cracking of this type tends to progress internally in directions transverse and longitudinal to the rail axis, making it undetectable by external visual inspection.
- Shelling damage was due to excessive wear.

The investigation determined that the broken rail had experienced a subsurface fatigue crack. It is not known whether the subsurface fatigue crack existed when the rail flaw detection car passed over the rail approximately six months before the derailment. A walking inspection of the track had identified that the rail should be replaced. Due to the lack of clear maintenance criteria for "other than main tracks", the priority of the corrective action

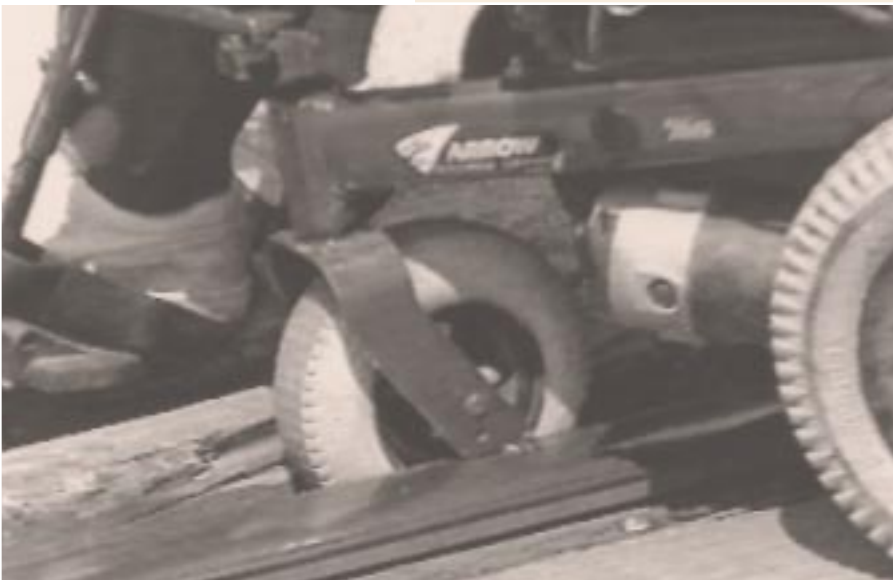
Wheelchair of the same type as one of those involved in the accident, but not with identical specifications, with a castor wheel in the field side of the rail.

While crossing over the single-track level crossing, the person in the leading wheelchair became immobilized just beside the south rail, when one of the front wheels fell into the field side of the flangeway.

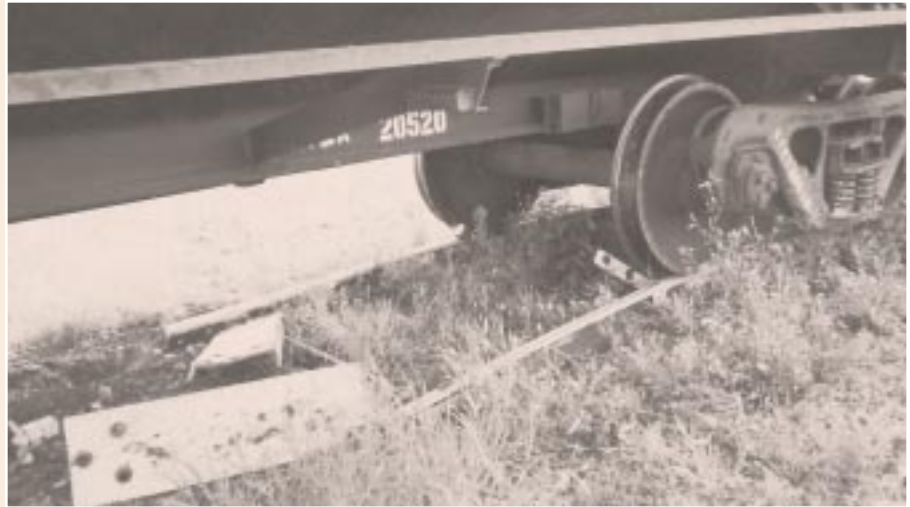
Trailing truck of the leading car at the damaged stop block.

CN subsequently issued new instructions for the Wesco spur requiring that rolling stock be grouped and secured with the appropriate number of handbrakes and that cars must rest against the stop blocks on tracks so equipped. CN also retrofitted the stop blocks and modified the track layout at Cornwall.

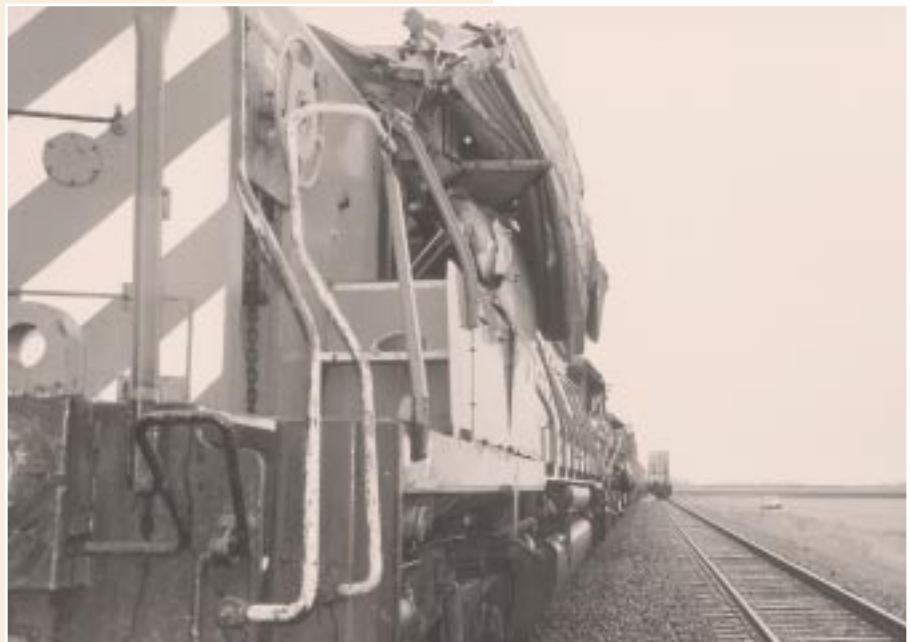
Wreckage of container from train 471 embedded in cab of lead locomotive of train 472.
